## **FEASIBILITY STUDY REPAIR vs REBUILDING OF BROOKTON MEMORIAL HALL**

**19 October 2019 – Brookton Memorial Hall W.A 6306**

**Feasibility Report**  
**Ref No.: 285**

**RE: FEASIBILITY STUDY COMPARING COSTS OF REPAIRING vs REBUILDING  
BROOKTON MEMORIAL HALL**

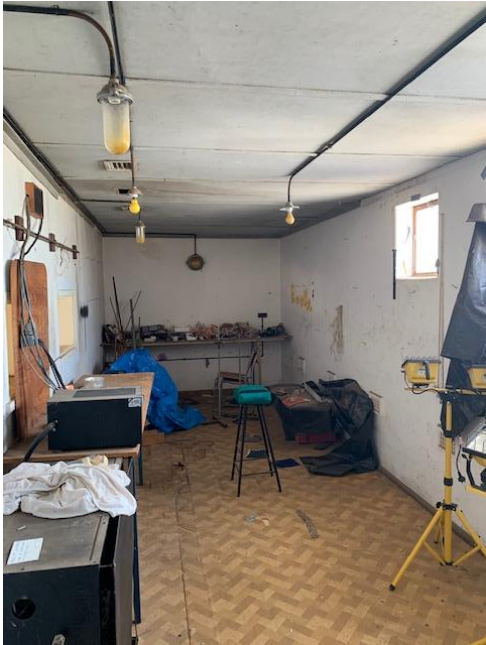
<p>Reference picture 1: Projector room</p>	<p>Reference picture 2: Stairwell ceiling and walls</p>

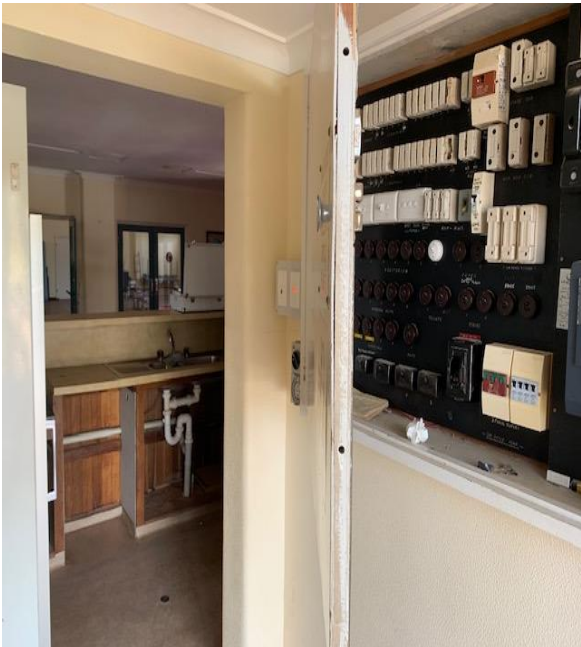
<p>Reference picture 3: Side entrance switchboard, lino and sink.</p>	<p>Reference picture 4: Equipment room walls and ceiling.</p>

Based on the survey the switchboards require replacement. The other asbestos areas require removal or sealing to control the asbestos risk. Refer to the asbestos report in the Appendix for further details.

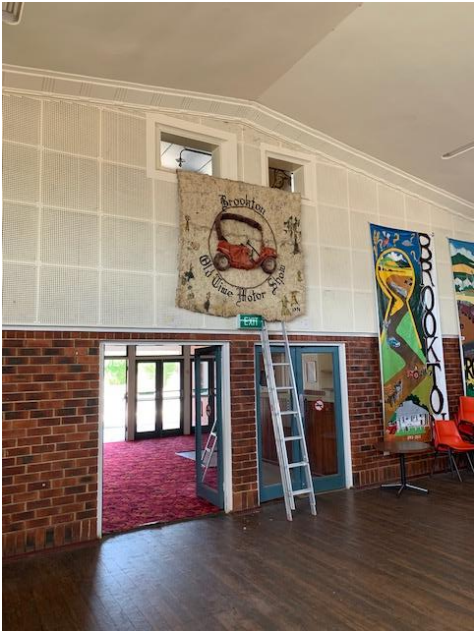
<p>Reference picture 5: Main hall south wall.</p>	<p>Reference picture 6: Underside of kitchen sink.</p>

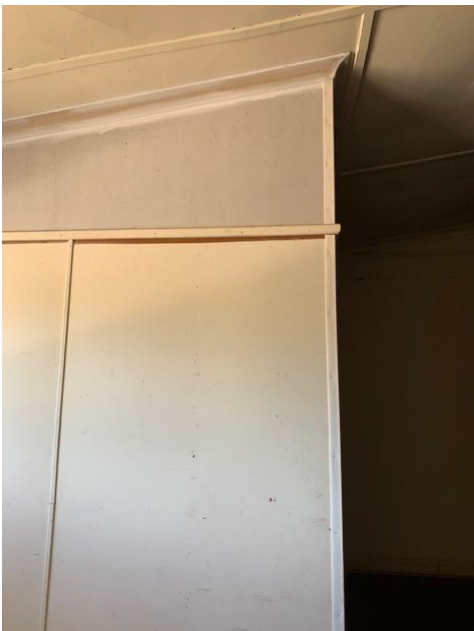
<p>Reference picture 7: Stage change room walls.</p>	<p>Reference picture 8: North gable end (external).</p>

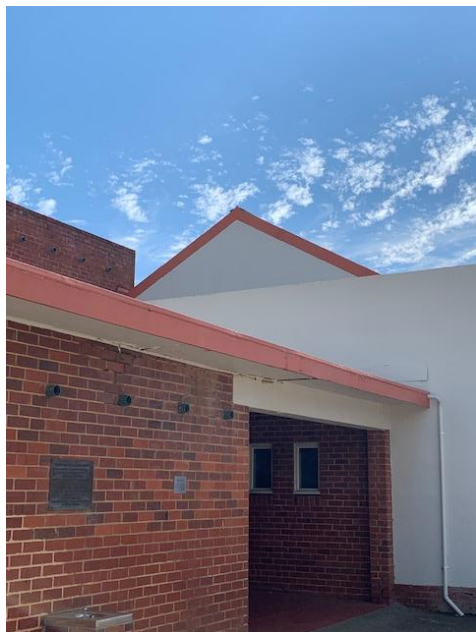
Reference picture 9:  
West gable end on roof.

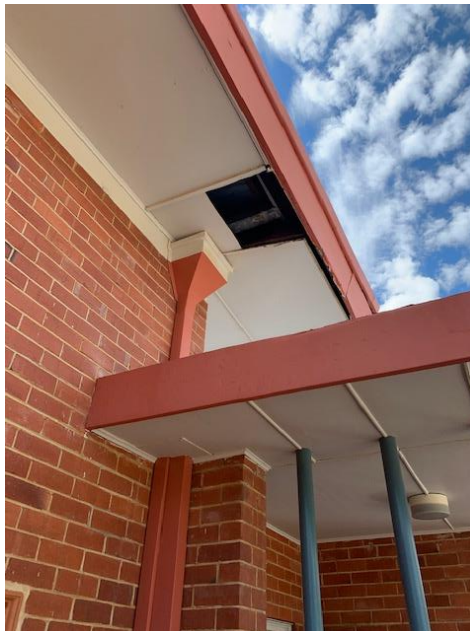
Building eaves	Presumed ACM from previous survey	10	Panels	Good, broken in some areas	Non-friable	<1m <sup>2</sup>	Low	3	No		Remove when convenient	Open

Reference picture 10:  
Building eaves.
