## Asbestos Survey

### Brookton Memorial Hall

Survey Date: 3<sup>rd</sup> of October 2019

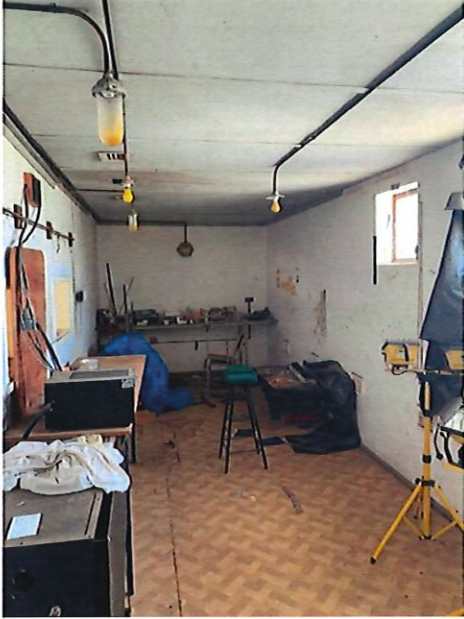
| <p>Reference picture 1:<br/>Projector room</p> | <p>Reference picture 2:<br/>Stairwell ceiling and walls</p> |

| Location & Item description | Hazard Type | Photo ref# | Material I.D | Material Condition | Friability | Estimate Quantity | Disturbance potential | Risk Rating | Label | Control Priority | Control recommendation/ comments | Status | Record work undertaken |
|---|---|---|---|---|---|---|---|---|---|---|---|---|---|
| Projector room wall | Chrysotile Amosite | 1 | Panels | Poor, unsealed, damaged in some areas | Friable | 10 - 50m <sup>2</sup> | Medium | 1 | No | | Removal or sealing the panels will control | Open | |
| Projector room ceiling | Chrysotile Amosite | 1 | Panels | Poor, unsealed, damaged in some areas | Friable | 10 - 50m <sup>2</sup> | Medium | 1 | No | | Removal or sealing the panels will control | Open | |
| Switchboards (3) | Presumed ACM from previous survey | 1 | Zelenite | Good | Non-friable | <1m <sup>2</sup> | Low | 3 | No | | Remove when convenient | Open | |
| Projector room lino, | No asbestos detected | 1 | | | | | | | | | | Closed | N/A |

| Client Sample ID | Eurofins Sample No. | Date Sampled | Sample Description | Result |
|---|---|---|---|---|
| PROJECTOR WALL | 19-Oc05557 | Oct 03, 2019 | Approximate Sample 2g / 25x15x5mm<br>Sample consisted of: Grey compressed fibre cement material | Chrysotile and amosite asbestos detected. |
| PROJECTOR CEILING | 19-Oc05558 | Oct 03, 2019 | Approximate Sample 1g / 30x20x3mm<br>Sample consisted of: Grey compressed fibre cement material | Chrysotile and amosite asbestos detected. |
| PROJECTOR LINO | 19-Oc05559 | Oct 03, 2019 | Approximate Sample 3g / 85x62x2mm<br>Sample consisted of: a) Black bituminous fibrous sheet<br>b) Vinyl backing | No asbestos detected.<br>Organic fibre detected. |

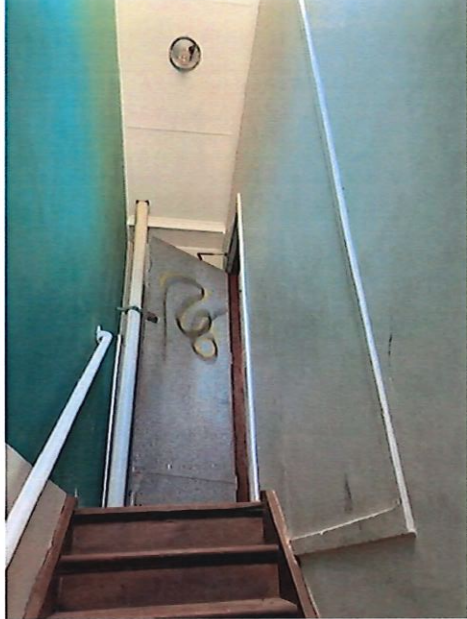
| Location & Item description | Hazard Type | Photo ref# | Material I.D | Material Condition | Friability | Estimate Quantity | Disturbance potential | Risk Rating | Label | Control Priority | Control recommendation/ comments | Status | Record work undertaken |
|---|---|---|---|---|---|---|---|---|---|---|---|---|---|
| Stairwell ceiling and wall panel | No asbestos detected | 2 | | | | | | | | | | Closed | N/A |

| Client Sample ID | Eurofins Sample No. | Date Sampled | Sample Description | Result |
|---|---|---|---|---|
| STAIRWELL CEILING | 19-Oc05560 | Oct 03, 2019 | Approximate Sample < 1g / 20x12x5mm<br>Sample consisted of: Grey fibre cement material | No asbestos detected.<br>Organic fibre detected. |
| STAIRWELL WALL | 19-Oc05561 | Oct 03, 2019 | Approximate Sample 8g / 70x30x7mm<br>Sample consisted of: White plaster material | No asbestos detected.<br>Organic fibre detected.<br>No respirable fibres detected. |

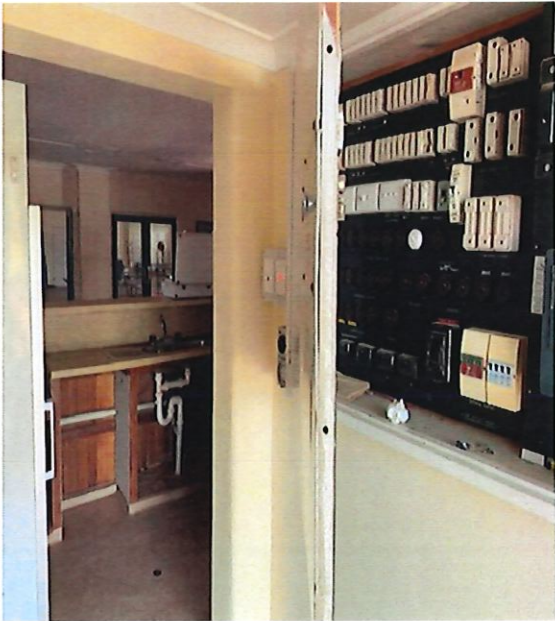
| <p>Reference picture 3:<br/>Side entrance switchboard, lino and sink.</p> | <p>Reference picture 4:<br/>Equipment room walls and ceiling.</p> |

| Location & Item description | Hazard Type | Photo ref# | Material I.D | Material Condition | Friability | Estimate Quantity | Disturbance potential | Risk Rating | Label | Control Priority | Control recommendation/ comments | Status | Record work undertaken |
|---|---|---|---|---|---|---|---|---|---|---|---|---|---|
| Side entrance switchboard | Presumed ACM from previous survey | 3 | Zelenite | Good | Non-friable | <1m <sup>2</sup> | Low | 3 | No | | Remove when convenient | Open | |
| Side entrance lino | No asbestos detected | 3 | | | | | | | | | | Closed | N/A |

| Client Sample ID | Eurofins Sample No. | Date Sampled | Sample Description | Result |
|---|---|---|---|---|
| ENTRY LINO | 19-Oc05562 | Oct 03, 2019 | Approximate Sample 2g / 60x20x2mm<br>Sample consisted of: a) Brown flexible vinyl sheet<br>b) Yellow adhesive | No asbestos detected.<br>Synthetic mineral fibre detected.<br>Organic fibre detected. |

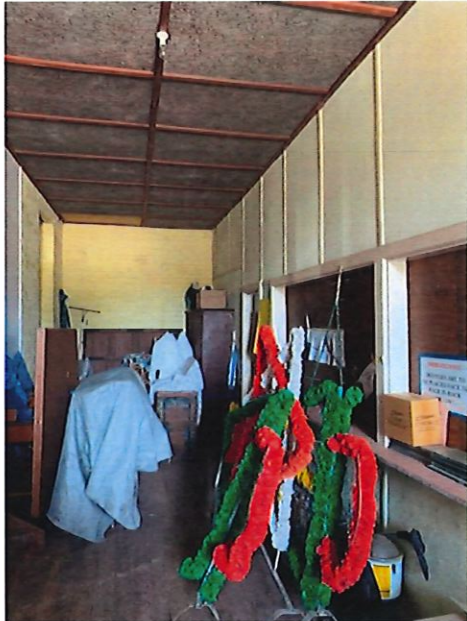
| Location & Item description | Hazard Type | Photo ref# | Material I.D | Material Condition | Friability | Estimate Quantity | Disturbance potential | Risk Rating | Label | Control Priority | Control recommendation/ comments | Status | Record work undertaken |
|---|---|---|---|---|---|---|---|---|---|---|---|---|---|
| Equipment room walls | Chrysotile Amosite | 4 | Panels | Poor, sealed but damaged in some areas | Friable | 10 - 50m <sup>2</sup> | Medium | 2 | No | | Removal or sealing the panels will control | Open | |
| Equipment room ceiling | No asbestos detected | 4 | | | | | | | | | | Closed | N/A |

| Client Sample ID | Eurofins Sample No. | Date Sampled | Sample Description | Result |
|---|---|---|---|---|
| EQUIPMENT ROOM WALL | 19-Oc05563 | Oct 03, 2019 | Approximate Sample 24g / 120x30x4mm<br>Sample consisted of: Grey compressed fibre cement material | Chrysotile and amosite asbestos detected. |

| Client Sample ID | Eurofins Sample No. | Date Sampled | Sample Description | Result |
|---|---|---|---|---|
| EQUIPMENT ROOM<br>CEILING | 19-Oc05565 | Oct 03, 2019 | Approximate Sample < 1g / 80x15x2mm<br>Sample consisted of: a) Organic fibre bundles<br>b) Cement backing/coating | No asbestos detected.<br>Organic fibre detected. |

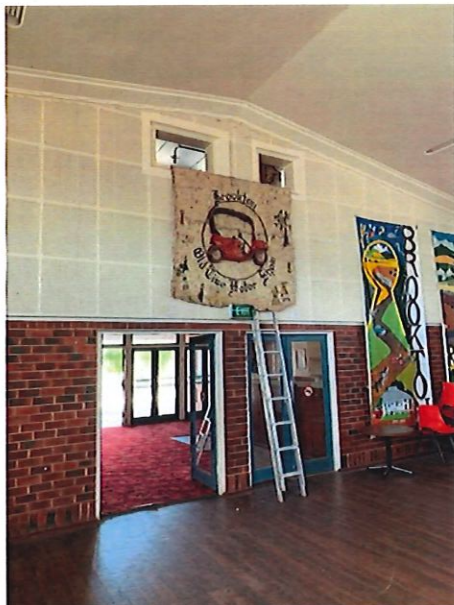
| Location & Item description | Hazard Type | Photo ref# | Material I.D | Material Condition | Friability | Estimate Quantity | Disturbance potential | Risk Rating | Label | Control Priority | Control recommendation/ comments | Status | Record work undertaken |
|---|---|---|---|---|---|---|---|---|---|---|---|---|---|
| Main hall south wall above entry | No asbestos detected | 5 | | | | | | | | | | Closed | N/A |

Reference picture 5:  
Main hall south wall.

| Client Sample ID | Eurofins Sample No. | Date Sampled | Sample Description | Result |
|---|---|---|---|---|
| MAIN HALL WALL | 19-Oc05566 | Oct 03, 2019 | Approximate Sample 21g / 60x55x15mm<br>Sample consisted of: White plaster board | No asbestos detected.<br>Organic fibre detected.<br>No respirable fibres detected. |

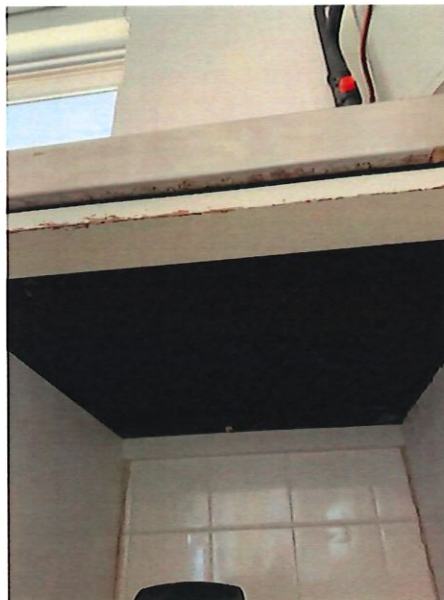
| Location & Item description | Hazard Type | Photo ref# | Material I. D | Material Condition | Friability | Estimate Quantity | Disturbance potential | Risk Rating | Label | Control Priority | Control recommendation/ comments | Status | Record work undertaken |
|---|---|---|---|---|---|---|---|---|---|---|---|---|---|
| Main kitchen sink | Presumed ACM from previous survey | 6 | Black material under sink | Good | Non-friable | <1m <sup>2</sup> | Low | 3 | No | | Remove when convenient | Open | |

Reference picture 6:  
Underside of kitchen sink.

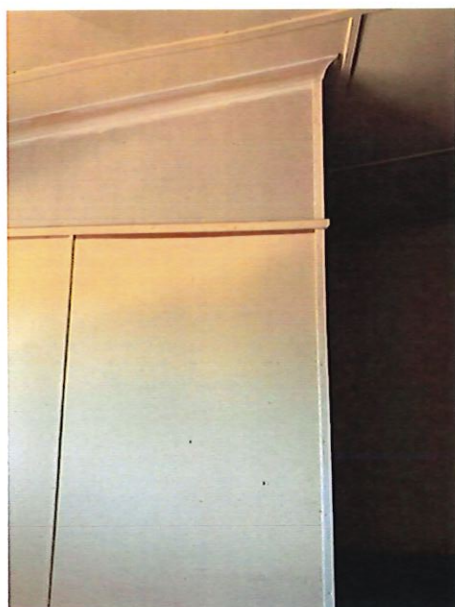
| Location & Item description | Hazard Type | Photo ref# | Material I. D | Material Condition | Friability | Estimate Quantity | Disturbance potential | Risk Rating | Label | Control Priority | Control recommendation/ comments | Status | Record work undertaken |
|---|---|---|---|---|---|---|---|---|---|---|---|---|---|
| Stage change room walls | No asbestos detected | 7 | | | | | | | | | | Closed | N/A |

Reference picture 7:  
Stage change room walls.

| Client Sample ID | Eurofins Sample No. | Date Sampled | Sample Description | Result |
|---|---|---|---|---|
| CHANGE ROOM WALL | 19-Oc05567 | Oct 03, 2019 | Approximate Sample < 1g / 20x10x2mm<br>Sample consisted of: Grey fibre cement material | No asbestos detected.<br>Organic fibre detected. |

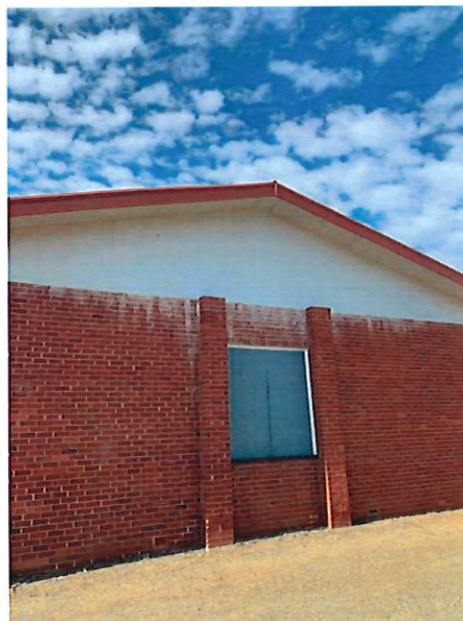
| Location & Item description | Hazard Type | Photo ref# | Material I. D | Material Condition | Friability | Estimate Quantity | Disturbance potential | Risk Rating | Label | Control Priority | Control recommendation/ comments | Status | Record work undertaken |
|---|---|---|---|---|---|---|---|---|---|---|---|---|---|
| North external gable end | Chrysotile Amosite | 8 | Panels | Sealed, good condition | Non-friable | 10 - 50m <sup>2</sup> | Low | 3 | No | | Removal or sealing the panels will control | Open | |

Reference picture 8:  
North gable end (external).

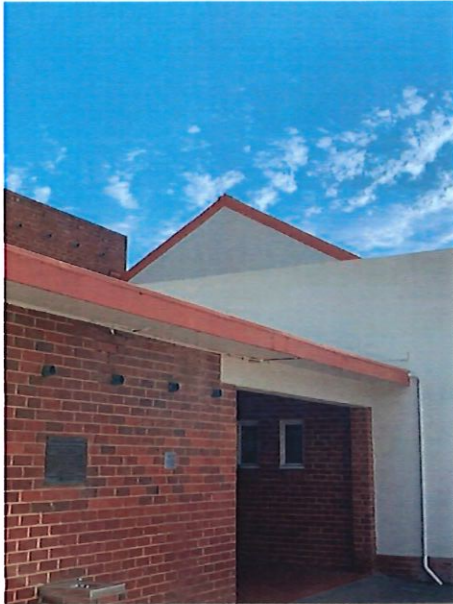
| Location & Item description | Hazard Type | Photo ref# | Material I. D | Material Condition | Friability | Estimate Quantity | Disturbance potential | Risk Rating | Label | Control Priority | Control recommendation/ comments | Status | Record work undertaken |
|---|---|---|---|---|---|---|---|---|---|---|---|---|---|
| West gable end on roof | Chrysotile Amosite | 9 | Panels | Sealed, good condition | Non-friable | 10 - 50m <sup>2</sup> | Low | 3 | No | | Removal or sealing the panels will control | Open | |

Reference picture 9:  
West gable end on roof.

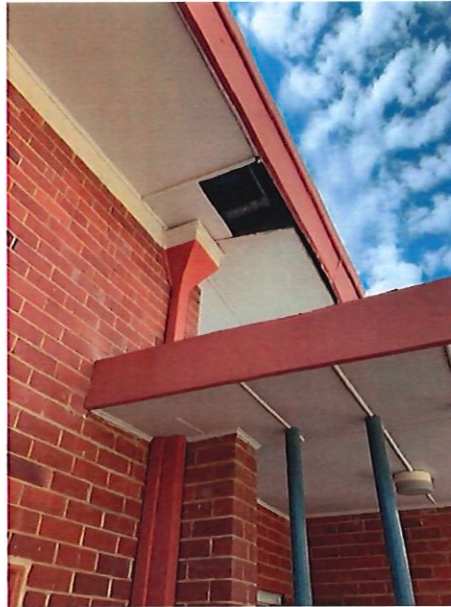
| Location & Item description | Hazard Type | Photo ref# | Material I. D | Material Condition | Friability | Estimate Quantity | Disturbance potential | Risk Rating | Label | Control Priority | Control recommendation/ comments | Status | Record work undertaken |
|---|---|---|---|---|---|---|---|---|---|---|---|---|---|
| Building eaves | Presumed ACM from previous survey | 10 | Panels | Good, broken in some areas | Non-friable | <1m <sup>2</sup> | Low | 3 | No | | Remove when convenient | Open | |

Reference picture 10:  
Building eaves.
