ORDINARY MEETING OF COUNCIL

MINUTES

14 DECEMBER 2023

11.12.23	DISCLOSURE OF INTERESTS	6
12.12.23	TECHNICAL & DEVELOPMENT SERVICES REPORTS.....	7
12.12.23.01	SUBDIVISION APPLICATION WAPC 164217: LOTS 51 & 181 BOYAGARRA ROAD	7

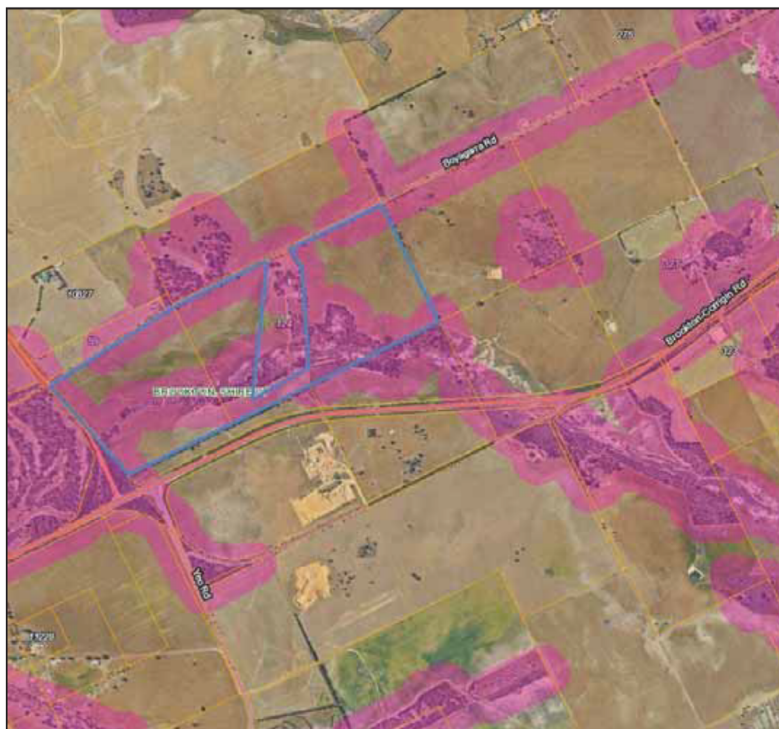
Figure 2: Bushfire Prone Areas (OBRM, 2019)

The publicly released Bushfire Prone Area Mapping (OBRM, 2019) shows that the majority of the site is located within a Bushfire Prone Area (within 100m of >1ha of bushfire prone vegetation) and as such is subject to a planning assessment of the bushfire risks. Bushfire Prone Area Mapping (OBRM, 2019) is shown in Figure 3.

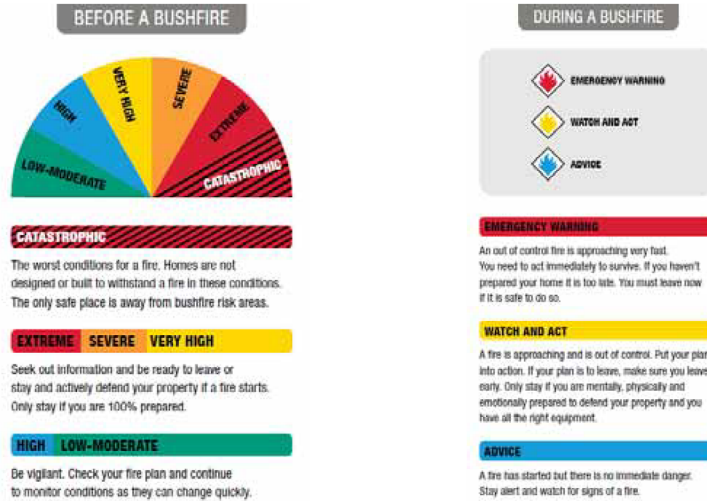
Figure 7: DFES Warning Systems

The DFES FDR ratings and warning systems are shown over the page on Figure 8.

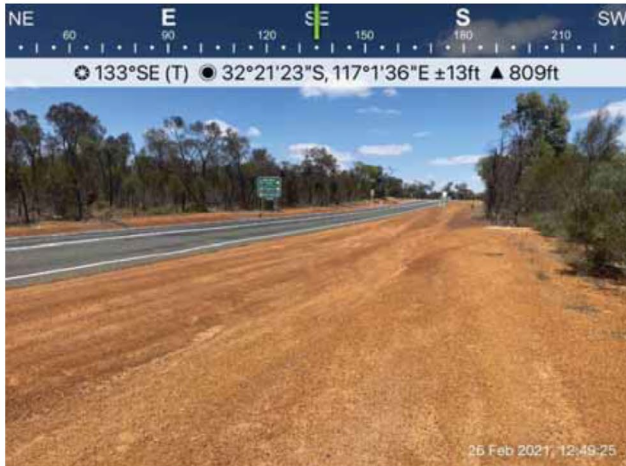
Plot	1	Classification or Exclusion Clause	Low fuel or non-vegetated areas exclusion 2.2.3.2 (e)

<p>Location: External to the Subject Site, includes public roads surrounding the site.</p> <p>Description: Roads, driveways, buildings, and other hardstand areas as per Exclusion 2.2.2.3 (e) of AS3959-2018.</p>

Photo Id 1: View to the southeast along Great Southern Highway located west of the Subject Site

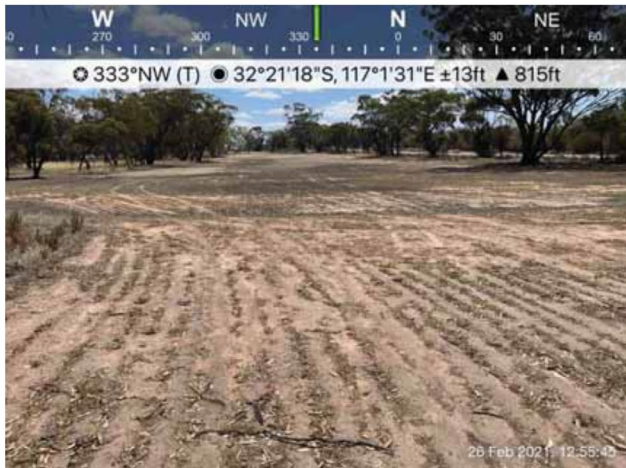
<p>Location: External to the Subject Site within adjacent property with dwelling and to the west within the Brookton Golf Course.</p> <p>Description: Maintained gardens and lawns in APZ areas surrounding existing buildings and golf course to the west of the Subject Site. Excluded as per AS3959 exclusion clause 2.2.3.2 (f) of AS3959.</p> <p>Available fuel loading: <2 t/ha.</p>
Photo 1d 3: View to the north northwest of golf fairway within the Brookton Golf Course located to the west of the Subject Site.			
Plot	2 cont.	Classification or Exclusion Clause	Low fuel or non-vegetated areas exclusion 2.2.3.2 (f)

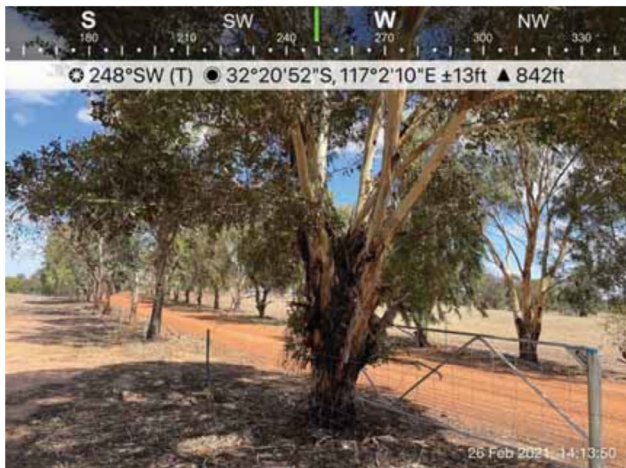
Additional Photo of Plot 2.
Photo 1d 4: View to the west southwest of maintained windbreak and driveway in neighbouring property, located in the north outside of the Subject Site boundary.

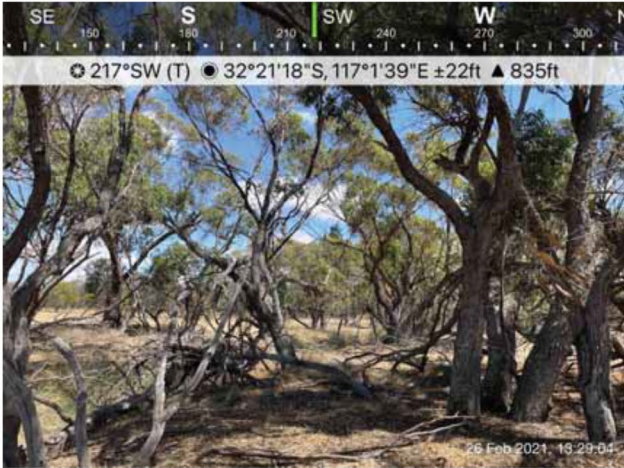
Plot	3	Classification or Exclusion Clause	Forest Type A

<p>Location: Internal to Subject Site, within the creek line in the east of the site and two small areas in the creekline in the far west of the site.</p> <p>Separation Distance: 0m.</p> <p>Description: York Gum Woodland - <i>Eucalyptus loxophleba</i> (York Gum) with isolated <i>Allocasuarina</i> sp. and <i>Acacia lasiocalyx</i> shrubland and a closed, dense non-native grassy understory.</p> <p>Average vegetation height: 6-10m.</p> <p>Vegetation Coverage: 30-70% foliage cover.</p> <p>Available fuel loading: 25-35t/ha.</p> <p>Effective slope: Downslope >0-5 degrees.</p>

Photo Id 5: View to the southwest of Forest Type A within creek line in the west of the Subject Site.

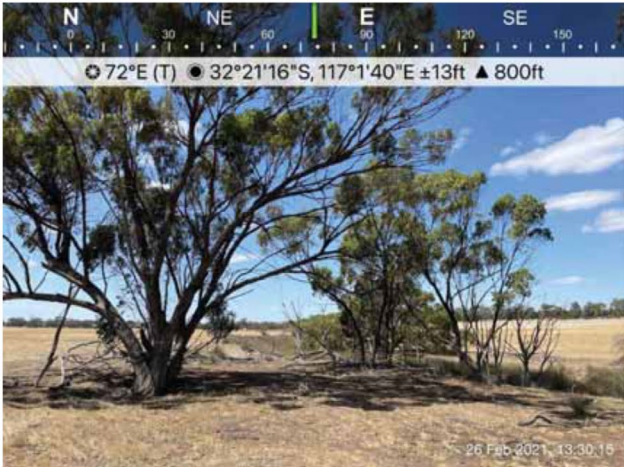
Plot	3 cont.	Classification or Exclusion Clause	Forest Type A

<p>Additional Photo of Plot 3.</p>

Photo Id 6: View to the east of Forest Type A within creek line in the west of the Subject Site.

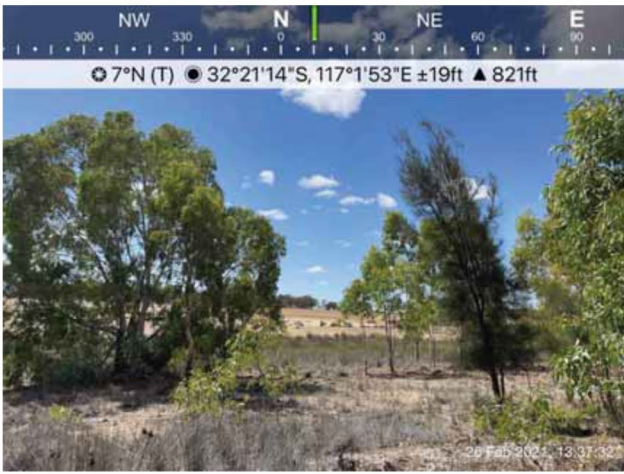
<p>Location: Internal to the site along the southern extent of the creek-line and external to the site within the golf course to the west, road reserves surrounding the site and an area to the north in adjacent property.</p> <p>Separation Distance: 0m and 15m to the north (within adjacent property).</p> <p>Description: York Gum Woodland - <i>Eucalyptus loxophleba</i> (York Gum) with isolated <i>Allocasuarina</i> sp. and <i>Acacia lasiocalyx</i> shrubland and a closed, dense non-native grassy understory.</p> <p>Average vegetation height: 6-10m.</p> <p>Vegetation Coverage: 30-70% foliage cover.</p> <p>Available fuel loading: 25-35t/ha.</p> <p>Effective slope: Upslope/flat.</p> <p>Note: Borderline Woodland Type B but precautionary principle applied.</p>

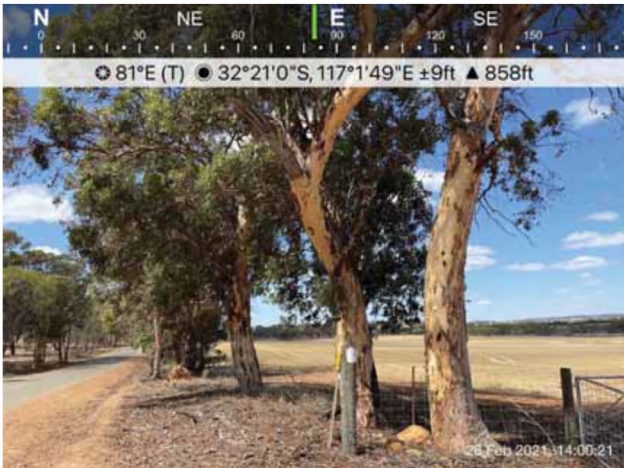
Plot	4 cont.	Classification or Exclusion Clause	Forest Type A

Additional Photo of Plot 4.

Photo Id 10: View to the east of Boyagarra Road reserve vegetation along the northern fence line located to the north of the Subject Site.

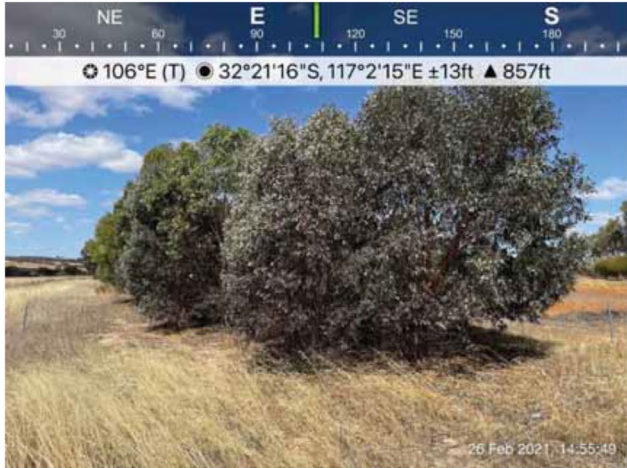
Additional Photo of Plot 4.
Photo Id 13: View to the east southeast of Forest Type A along Brookton-Corrigin Road to the south of the Subject Site.			
Plot	4 cont.	Classification or Exclusion Clause	Forest Type A

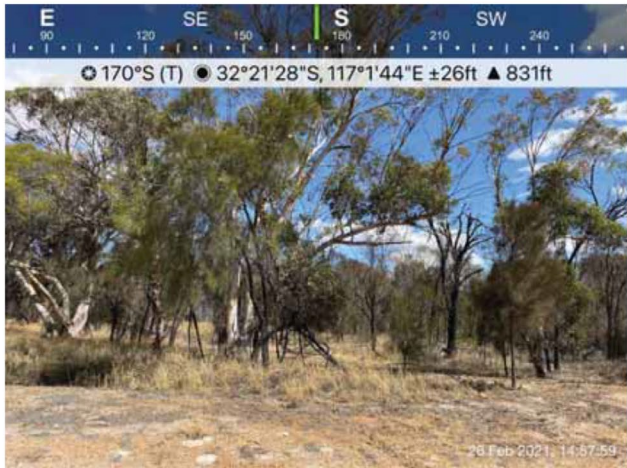
Additional Photo of Plot 4.
Photo Id 14: View to the south of Forest Type A within property to the southwest of the Subject Site.

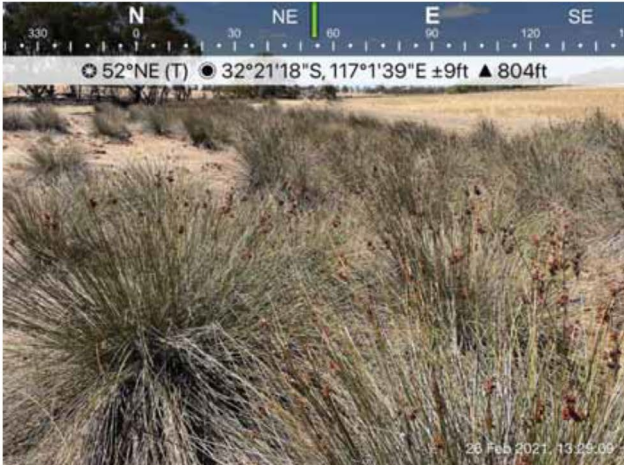
Plot	5	Classification or Exclusion Clause	Shrubland Type C

<p>Location: Internal to the Subject Site along the creek line.</p> <p>Separation Distance: 0m.</p> <p>Description: Dominated by <i>Juncus acutus</i>, (Invasive Spiny Rush) sedgeland in the semi-perennial wetter portion of the creek-line area.</p> <p>Average vegetation height: 1-2m.</p> <p>Vegetation Coverage: >30% foliage cover.</p> <p>Available fuel loading: 25t/ha.</p> <p>Effective slope: Downslope >0-5 degrees.</p>

Photo Id 15: View to the northeast of shrubland vegetation within creek line in the west of the Subject Site.

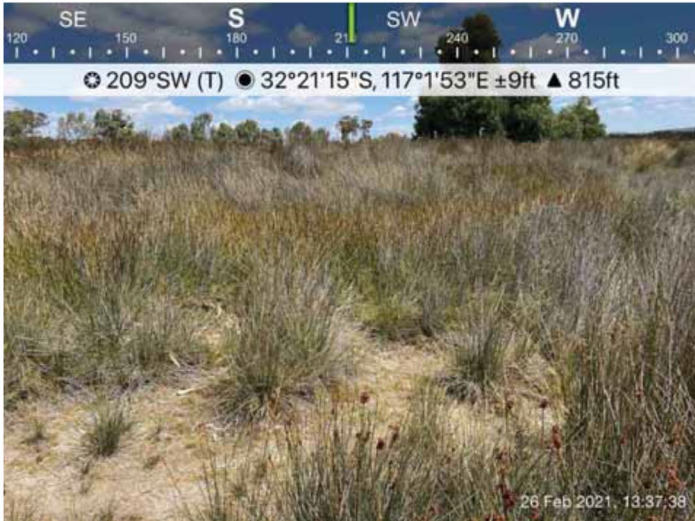
Plot	5 cont.	Classification or Exclusion Clause	Shrubland Type C

<p>Additional Photo of Plot 4.</p>

Photo Id 16: View to the southwest of shrubland vegetation within creek line in the west of the Subject Site.

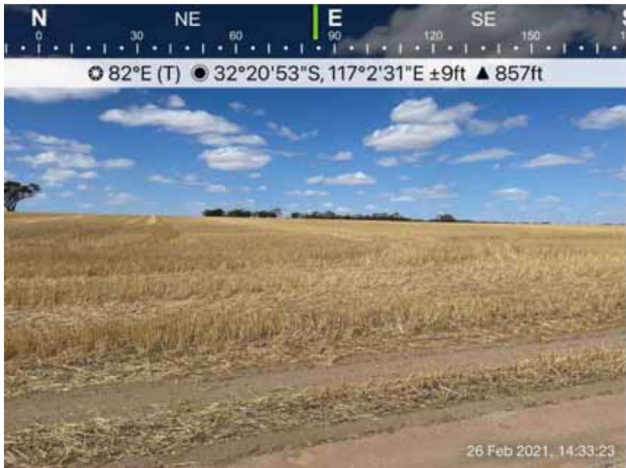
<p>Location: Internal to the Subject Site in the south and in adjacent agricultural properties to the north, east and south.</p> <p>Separation Distance: 0m.</p> <p>Description: Grazed paddocks consisting predominantly of harvested dryland cropping.</p> <p>Average vegetation height: 300mm.</p> <p>Vegetation Coverage: <10% trees.</p> <p>Available fuel loading: 4.5t/ha.</p> <p>Effective slope: Upslope/flat.</p>

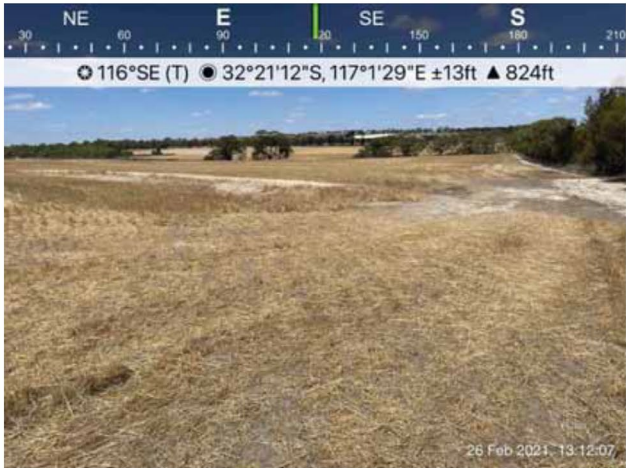
Plot	7	Classification or Exclusion Clause	Grassland Type G

<p>Location: Internal to the Subject Site north of the creekline.</p> <p>Separation Distance: 0m.</p> <p>Description: Grazed paddocks consisting predominantly of harvested dryland cropping.</p> <p>Average vegetation height: 300mm.</p> <p>Vegetation Coverage: <10% trees.</p> <p>Available fuel loading: 4.5t/ha.</p> <p>Effective slope: Upslope/flat.</p>

Photo Id 18: View to the east southeast of cropping paddock in the west of the Subject Site.

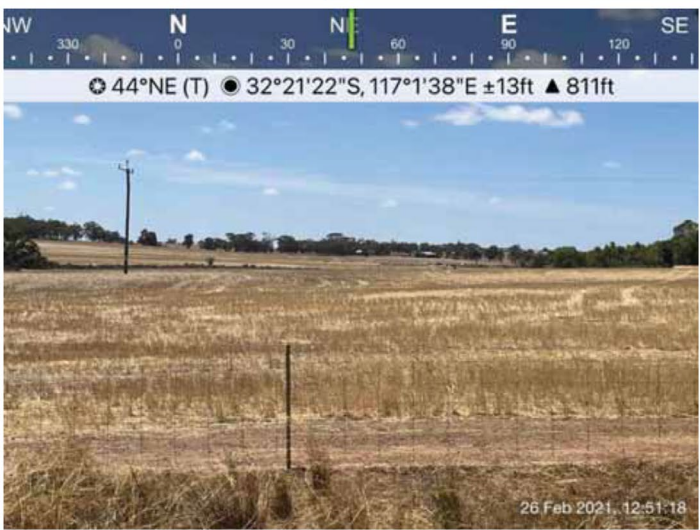
Additional Photo of Plot 7.
Photo Id 21: View to the northeast of cropping paddock in the west of the Subject Site.

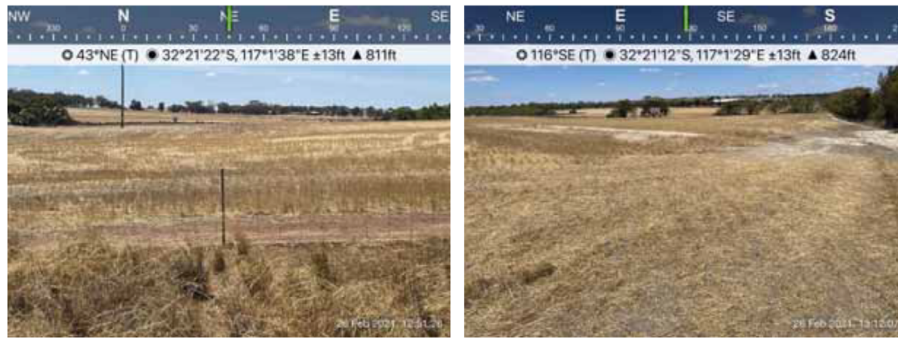
Figure 2: Photographs of the cleared areas within the Subject Site, showing general agricultural purposes.

Currently the Subject Site is being utilised for general agriculture (mixed rotation cropping and livestock) as shown on Figure 2, with no residential dwellings located within the Subject Site. There is a seasonal creek-line running from east to west through the centre of the Subject Site, that is surrounded by degraded remnant vegetation (Figure 3). Within the outer extents of the creek-line there are a few small dams used for livestock.

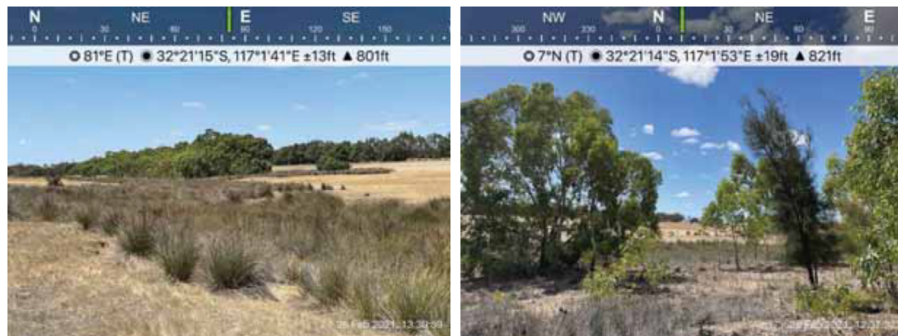
Figure 3: Photographs of the creek-line within the Subject Site, showing the presence of a mixed vegetation buffer.

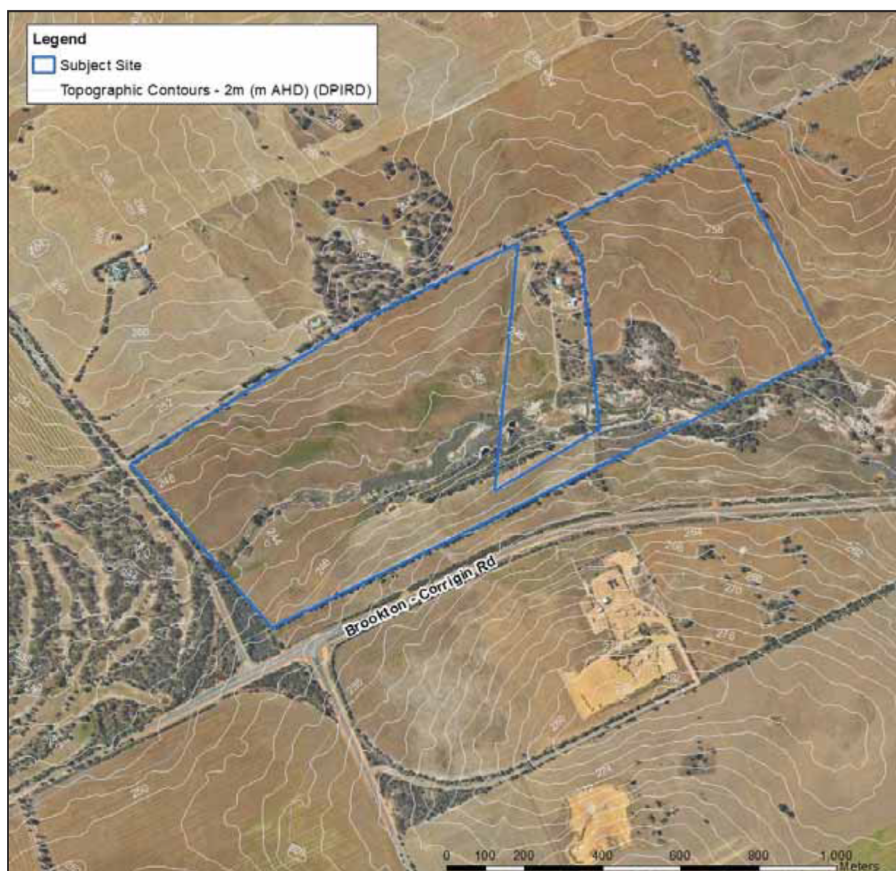
Figure 5: Topographic contours of Lot 51 and 181 Boyagarra Rd, the Subject Site.

The property is located in an undulating landscape in the Brookton area. The Subject Site slopes from the external boundaries down to the seasonal creek-line area, from a high point of 262m AHD to a low point of 242m AHD. The topographic contours for the site are shown on Figure 5.

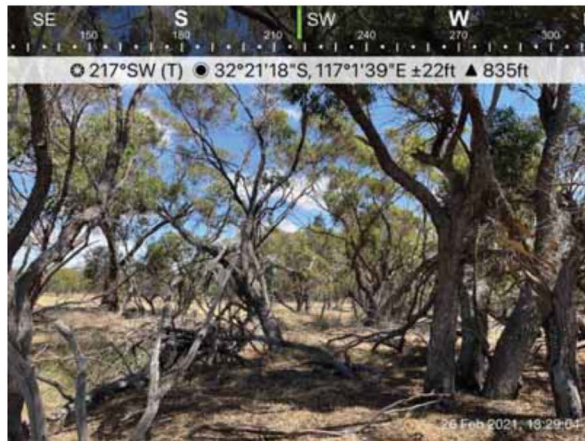
Figure 10: York Gum Woodland Vegetation unit within the Subject Site.

- York Gum Woodland (Figure 10) - *Eucalyptus loxophleba* (York Gum) Woodland (20-50% crown cover) with isolated *Allocasuarina* sp. and *Acacia lasiocalyx* shrubland and a closed, dense non-native grass understory. Dominant species described likely do not reflect pre-European vegetation community and are persistent relics remaining in the degraded state.

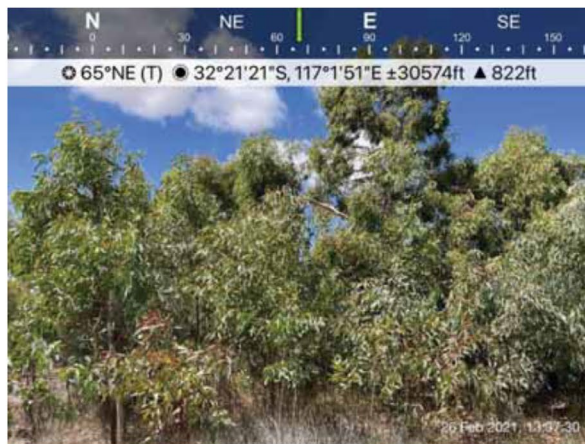
Figure 11: Dense stand of juvenile *Eucalyptus* sp. within the Subject Site.

- Dense stand of juvenile *Eucalyptus* sp. (Figure 11) – community responding from a recent fire (circa 2015-2016), and is a likely an alternate stable state of the York Gum Woodland Community. This indicates that the vegetation area surrounding the creek-line has an active soil seed bank and has capacity to respond to rehabilitation efforts.

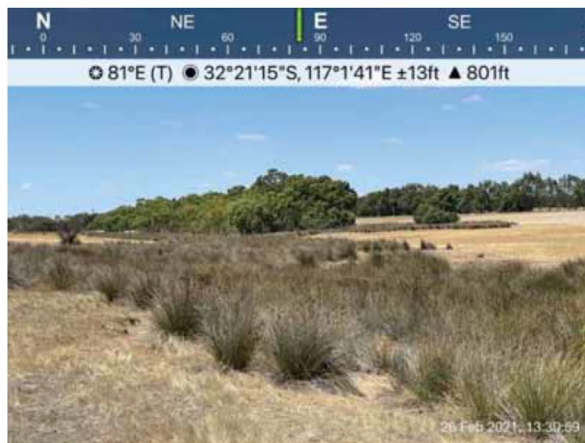
Figure 12: *Juncus acutus* sedgeland vegetation unit within the creek-line.

- *Juncus acutus* sedgeland (Figure 12) – Dominant *Juncus acutus*, Invasive Spiny Rush, sedgeland in the semi-perennial wetter portion of the creek-line area. Isolated native species present, but community dominated by the non-native *J. acutus*.

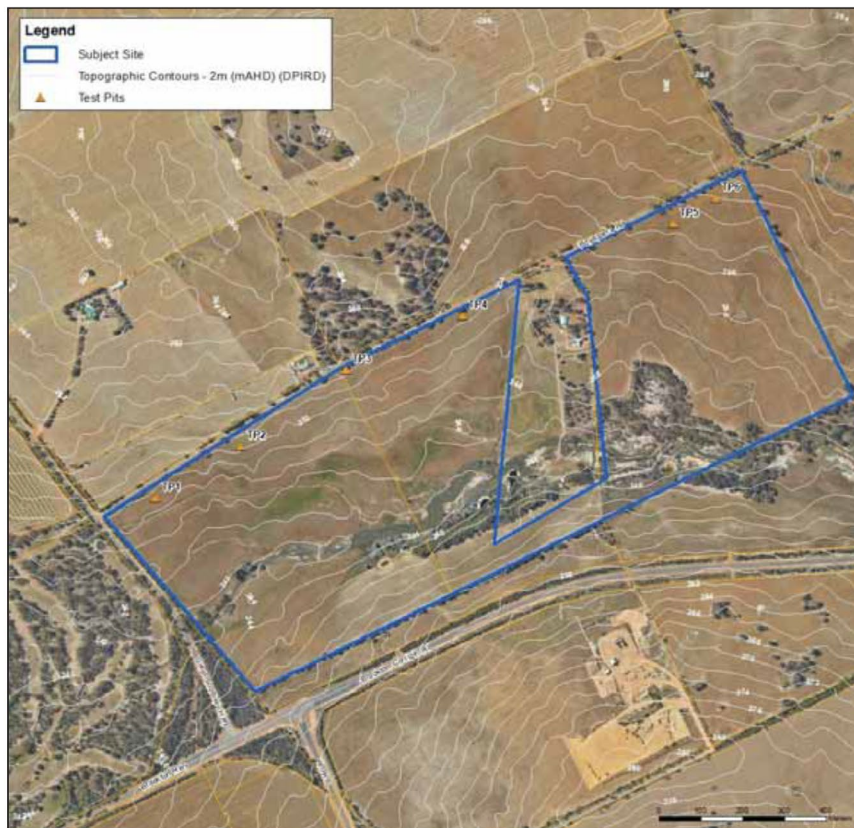
Figure 13: Test pit locations within the Subject Site, determined by proposed subdivision plan and location of building envelopes.

A soil investigation was conducted as part of the site assessment on the 26th February 2021. The soil testing was conducted to assess the suitability of the site for the proposed rezoning and subsequent subdivision and development, including suitability for onsite effluent disposal. Six test pits were constructed within the Subject Site, using a post hole digger to a depth of 600mm. The location of the test pits was selected based on the proposed subdivision plan and likely location of the building envelopes. The location of the test pits is shown on Figure 13. Soil testing was not conducted south of the creek line however a visual inspection across the site and a review of the aerial imagery shows the soil types found north of the creek likely extend south of the creek.

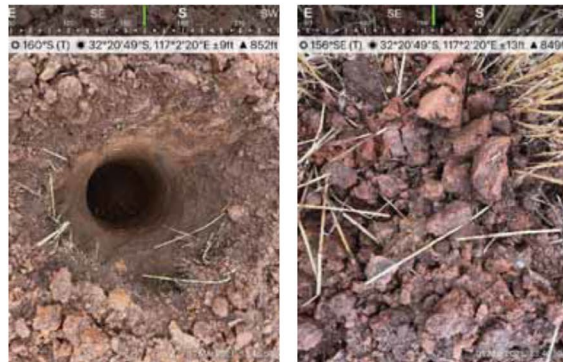
Figure 14: Photographs at soil type at TP2

Soil testing showed that three soil types were identified across the Subject Site; a topsoil of sand over a layer of sandy loam, over sandy clay (TP1 & TP2), a topsoil of sand, over loamy sandy gravel (TP3 & TP4) and a topsoil of sand over a cemented silt layer over clay/sandy clay. Further detail on soil profiles encountered at the Subject Site are presented in Table 2. Photographs showing the three soil types are shown in Figures 14 -16.

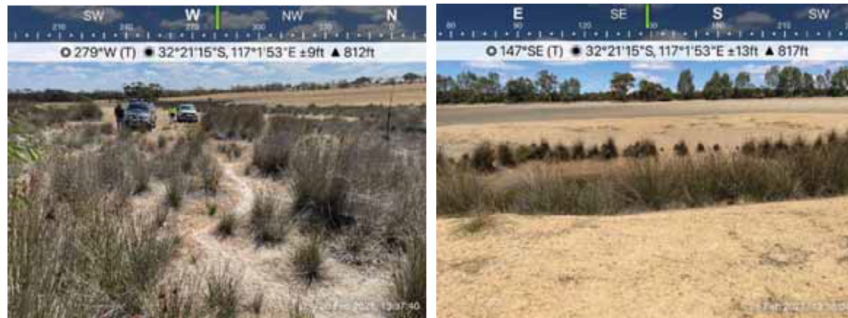
Figure 18: Photographs showing the dry creek bed and one of the man-made dams within the creek line.

A hydrological assessment of the Subject Site was also conducted on the 26th February 2021. The site was found to be very dry consistent with the time of year and there was no water within the creek line other than that in the man-made dams along the fringe of the creek. There was also no evidence of any other drainage network or water bodies other than the previously identified non-perennial creek, making it evident on the site that surface water, that did not infiltrate at source drained towards this creek. A photograph of the creek and one of the man-made dams are shown in Figure 18.

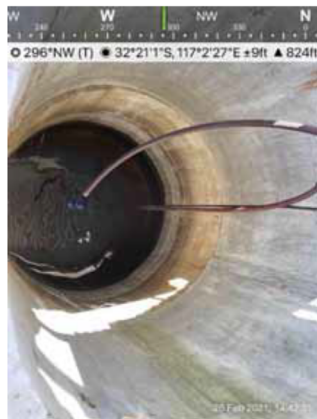
Figure 19: Photograph within the well showing the groundwater level

Groundwater was difficult to investigate onsite as there were no groundwater monitoring or production bores on site or expressions of groundwater to the surface evident. A groundwater measurement was taken from a well on the site and found to be 3m below ground level. The location of the well is shown on Figure 8, giving an indication of the depth of groundwater across the site. An image of the well is shown on Figure 19.

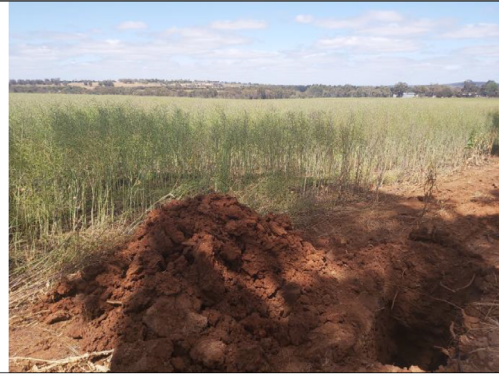
Photo 1: The Site near Block G, is looking from northern-west side

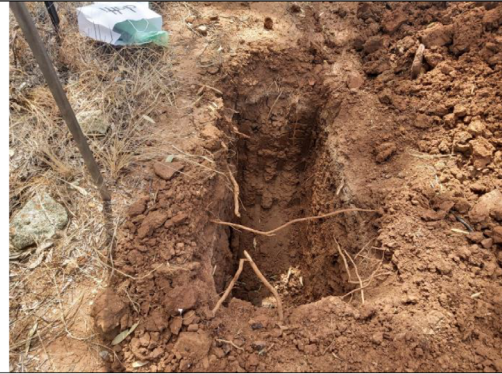
Photo 2: Soil Profile at Test Pit 1 (TP1)- Block G, Groundwater not observed

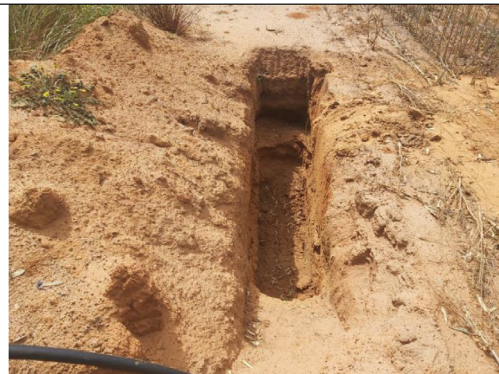
Photo 3: Soil Profile at Test Pit 1 (TP2)- Block F, Groundwater not observed

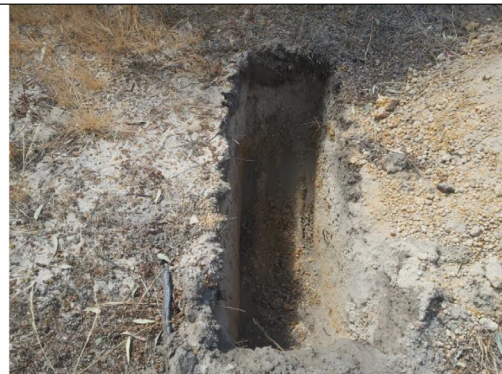
Photo 4: Soil Profile at Test Pit 3 (TP3)- Block E, Groundwater not observed

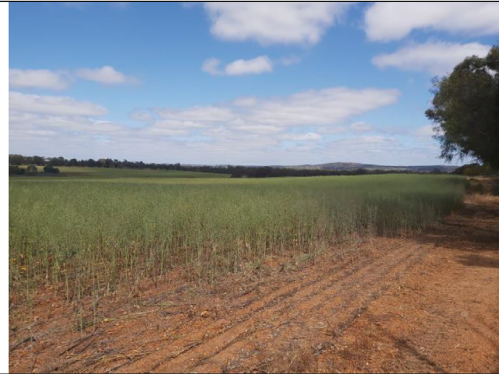
Photo 5: The Site near Block D, is looking from northern-west side

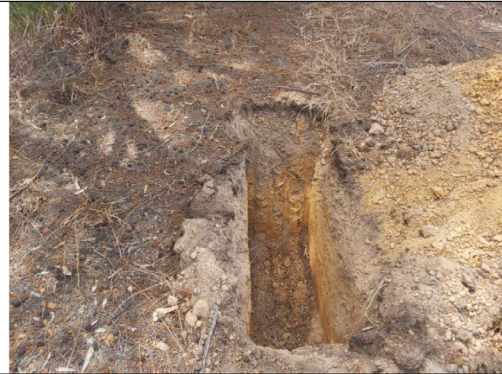
Photo 6: Soil Profile at Test Pit 4 (TP4)- Block D, Groundwater not observed

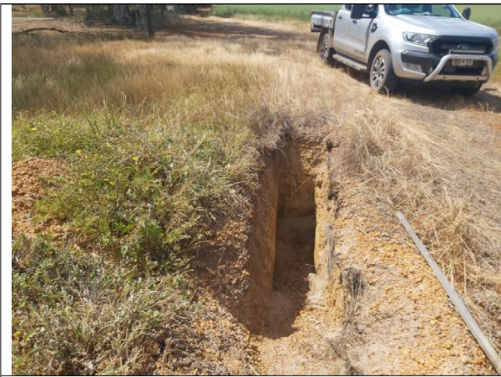
Photo 7: Soil Profile at Test Pit 5 (TP5)- Block C, Groundwater not observed

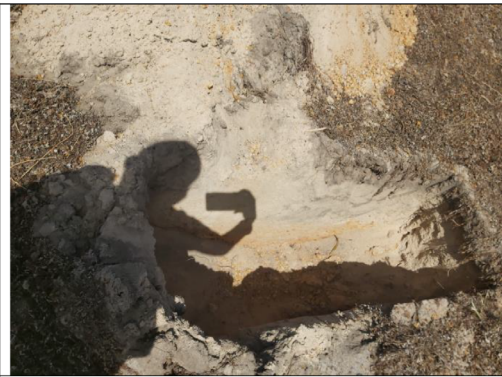
Photo 8: Soil Profile at Test Pit 6 (TP6)- Block B, Groundwater not observed

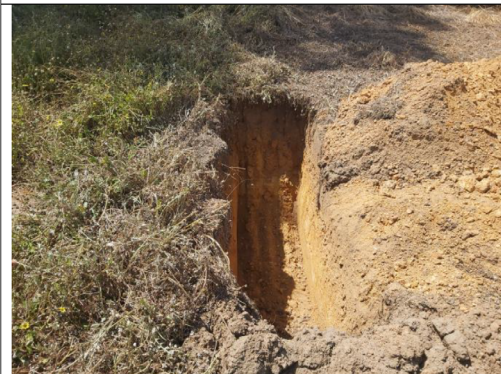
Photo 9: Soil Profile at Test Pit 7 (TP7)- Block A, Groundwater not observed

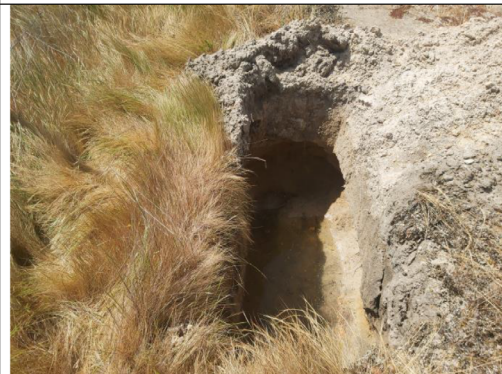
Photo 10: Soil Profile at Test Pit 9 (TP9)- land reserve area, Groundwater observed at 0.8m depth

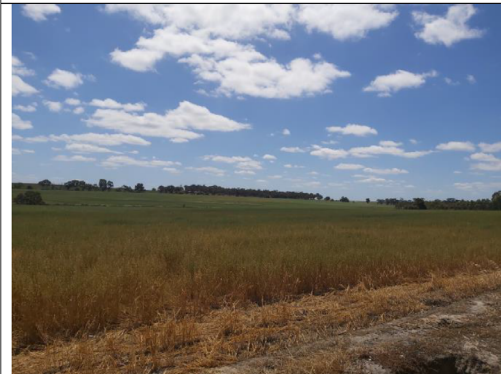
Photo 11: The Site near Block H, is looking from southern-east side

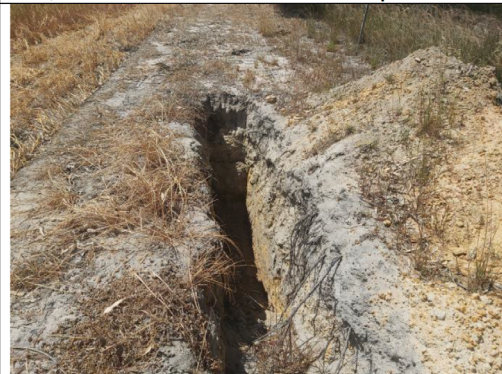
Photo 12: Soil Profile at Test Pit 8 (TP8)- Block H, Groundwater not observed

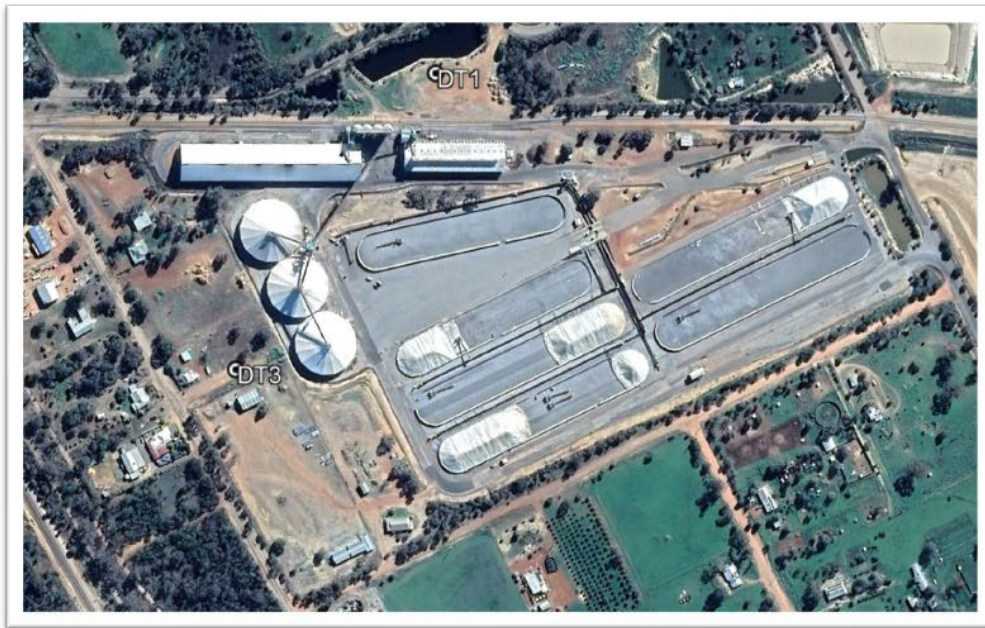
Figure A: Monitoring Locations (LOT 100)

LOT ID	DustTrak ID	Location Description
LOT 100	DT1	Northern site boundary, nearby to Horizontal Storage Sheds (HOR)
	DT3	Western Boundary, adjacent to silos and residential buildings
LOT 550	DT5	Northern site boundary

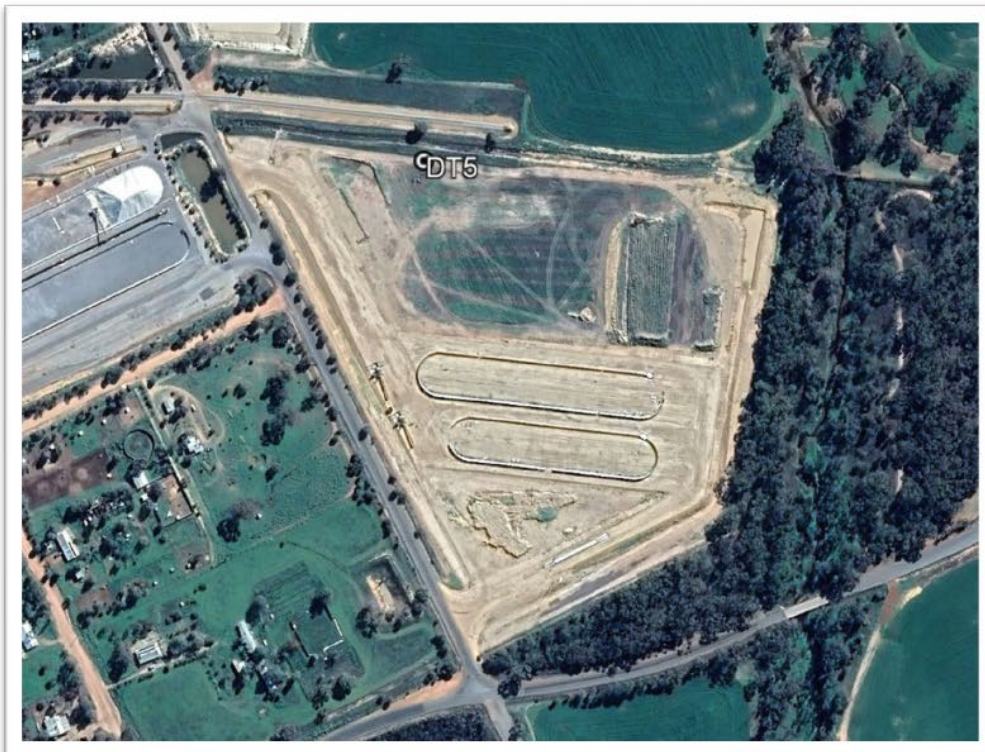
Figure B: Monitoring Locations (LOT 550)
